CONTRACT NAS8-21341

Final Report Covering Period May 1 Through September 11, 1968

DEMONSTRATION OF MANUFACTURING TECHNIQUES FOR APPLICATION OF HIGH PERFORMANCE CRYOGENIC INSULATION

D2-139267-1

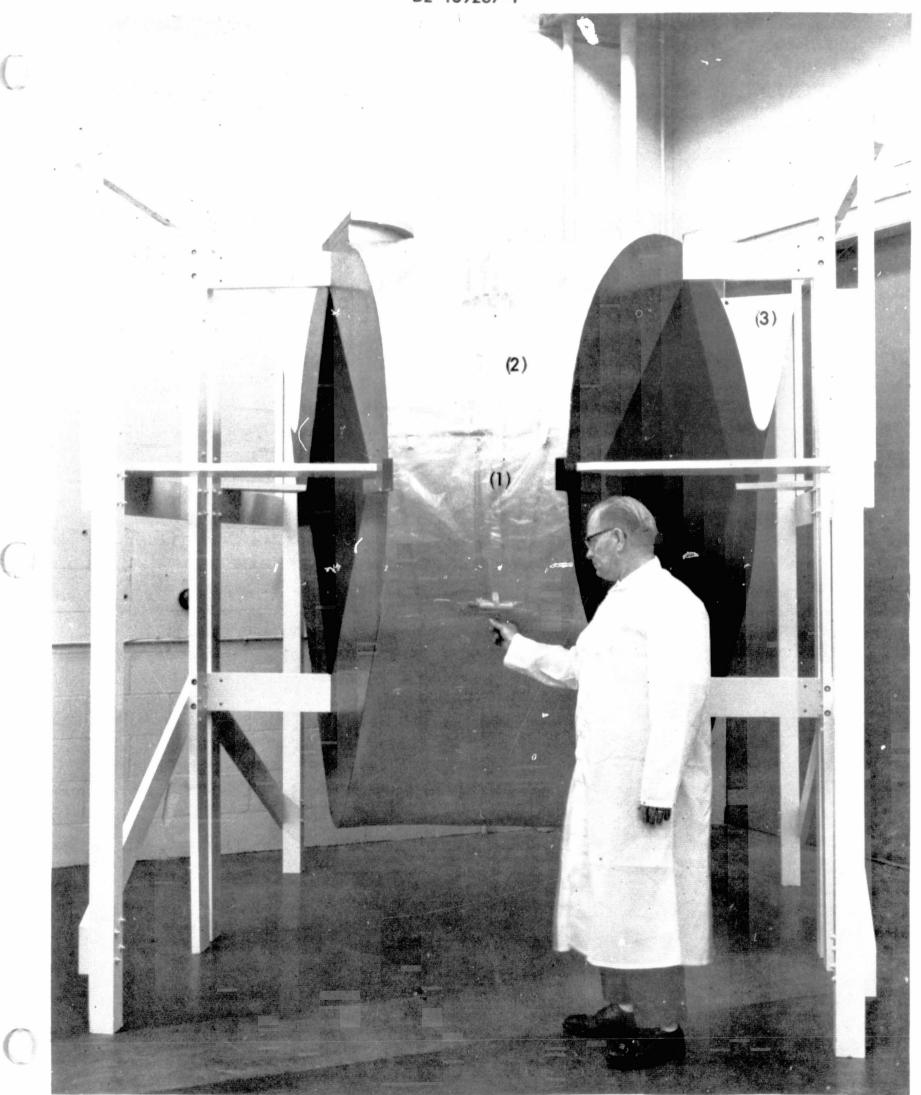
FIGURE 10
MOCK-UP WITH PURGE SYSTEM ATTACHED

A demonstration of the purge systems was conducted but the efficiency of the system could not be determined either quantitatively or qualitatively. Positive gas pressure inside the purge system segments could not be maintained which indicated a discrepancy exists in the hole size and/or hole pattern in the system. Adequate purging would require an even gas flow passing through the perforations from inflated purge sections.

A redesign of the purge distribution system is indicated and desirable. The system shown in the fabrication drawing will not perform as required to adequately distribute gas to the purge segments. A metallic manifold positioned around and attached to the vent relief port for stability is recommended. Lateral distribution segments radiating to the adjacent manholes would distribute the gas to the transfer tubes for each purge section.

A redesign of the purge gas distribution system is desirable. The method specified in the drawing specified that the tubes exit the insulation system in the vicinity of the manhole insulation cover to be connected to an external manifold. It is recommended that metal distribution manifolds be fabricated and installed around the vent valves with arms radiating from this to the proximity of the manhole on each side. This system would offer an unlimited number of vents connections to the distribution tubes of the purge system compartments.
